Technical Note 6-81

COMMUNICATIONS TESTS WITH TACTICAL RADIOS
IN A LARGE URBAN AREA

U. S. ARMY HUMAN ENGINEERING LABORATORY
Aberdeen Proving Ground, Maryland

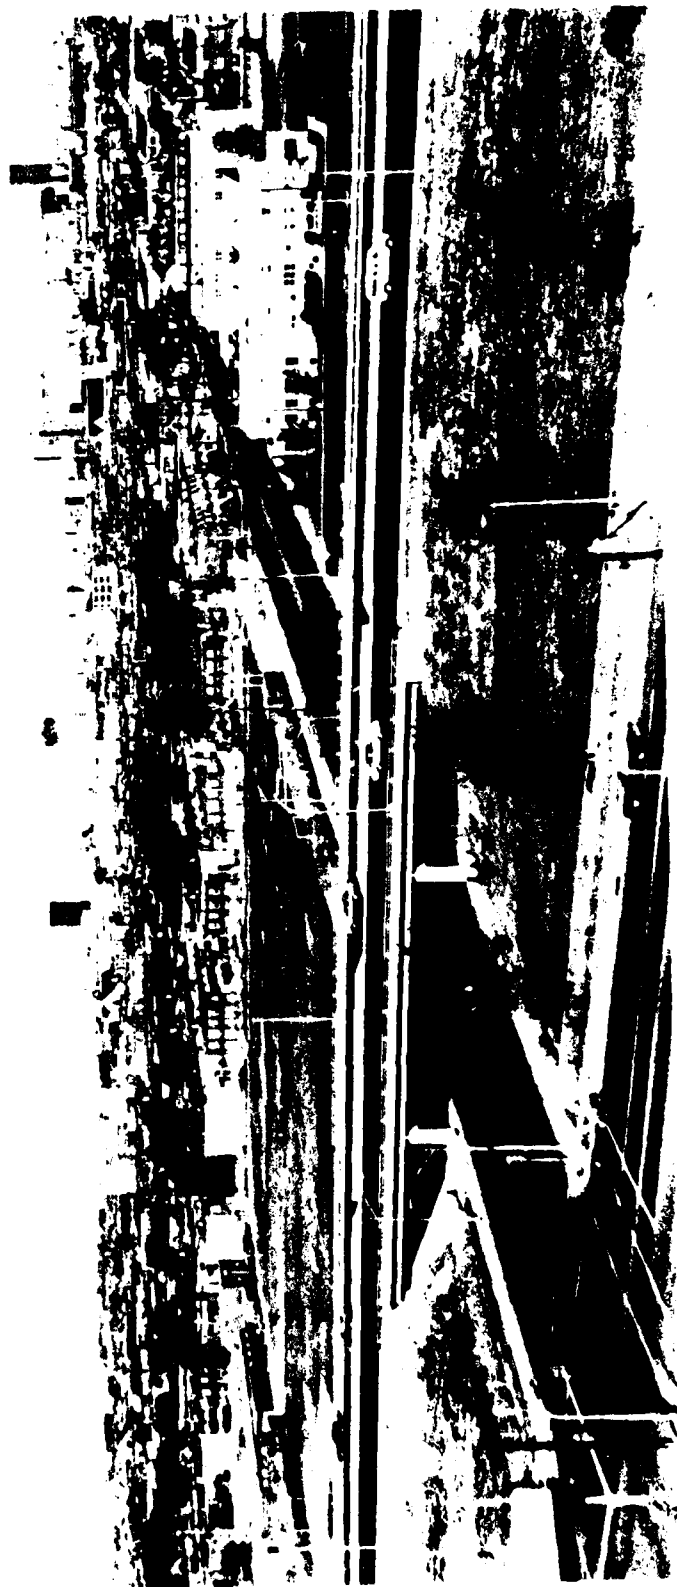
Figure 5. A view from the south end of Philadelphia looking north towards the city center. The case "B" and "C" trials were conducted toward this area.

Figure 4 shows the basic north-south and east-west test grids in the street-to-street tests. Actually, the street-to-street tests represented three levels of severity in a communications environment. The Broad Street leg which involved communications between an operator stationed at City Hall and an operator moving south on Broad Street represented the most favorable environment. On the Broad Street leg, there was no masking of line-of-sight by buildings (Case B). The next most severe communications environment was the cross-town leg of the north-south tests (Case C). In these tests the operator's line-of-sight was always masked by buildings, but the large masking buildings were limited in number. That is, communications were attempted between a position in the high-rise, core-area and a position outside the high-rise area (Figure 5).

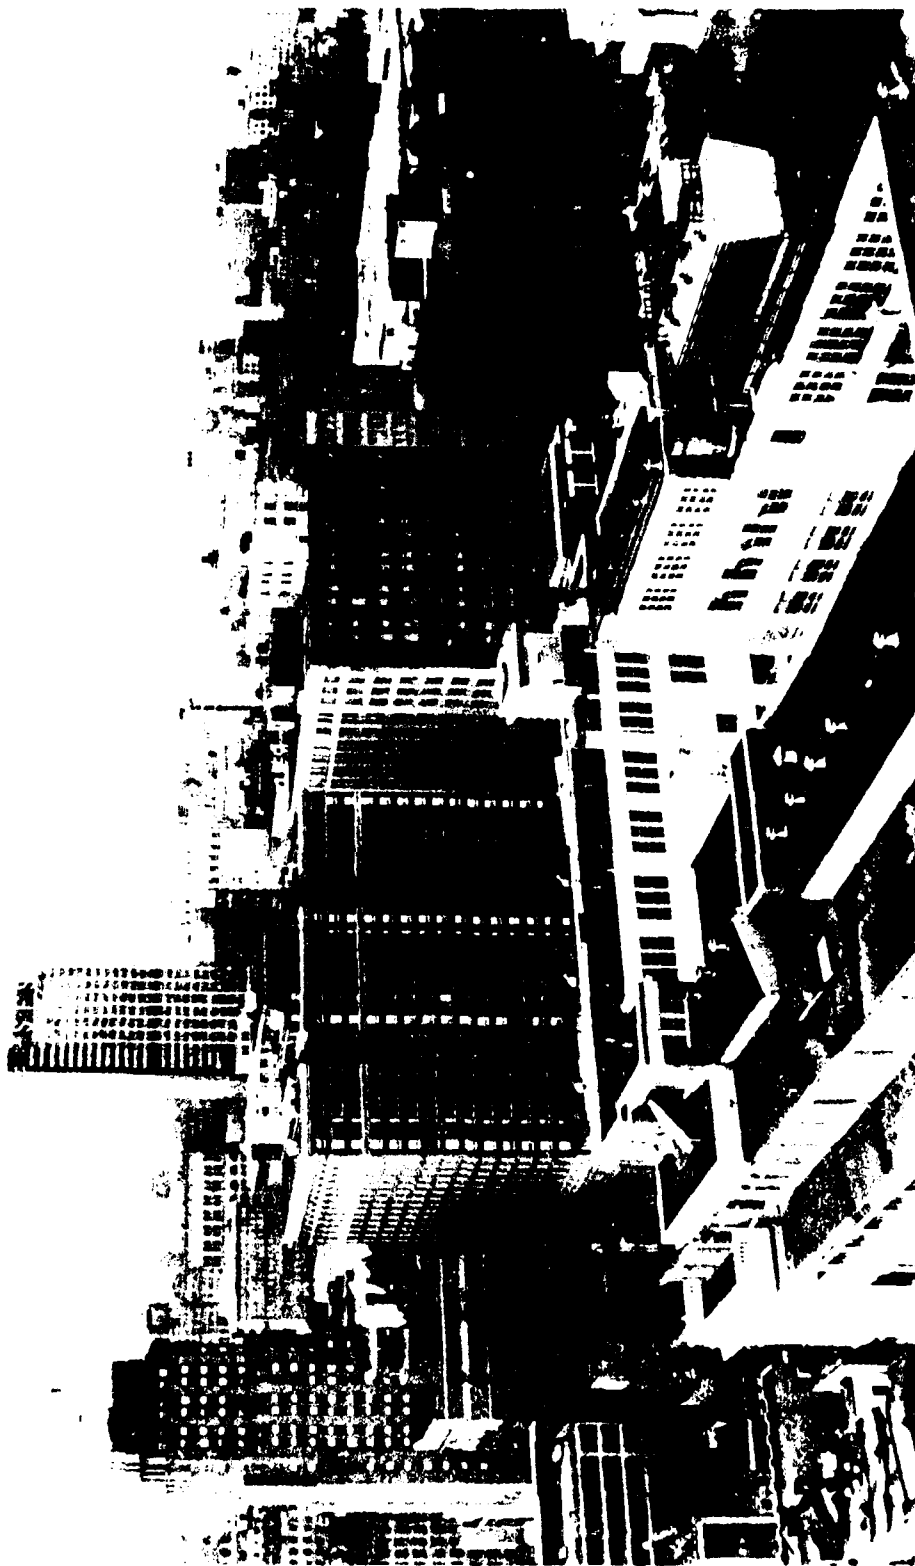
Figure 6. A view of the high-rise core area of Philadelphia looking west from the observation tower at Walnut & 6th Streets. All Case "D" communications attempts were made in this area.

The most severe environment occurred with the east-west grid (Case D). In these tests the stationary operator was located at City Hall as before, but operators moved along Chestnut Street and at each communication attempt were positioned approximately 100 feet back from the Chestnut Street intersection. All the east-west tests were conducted in the high-rise, core-area of Philadelphia which stretched from the Schuylkill River to the Delaware River (Figure 6).

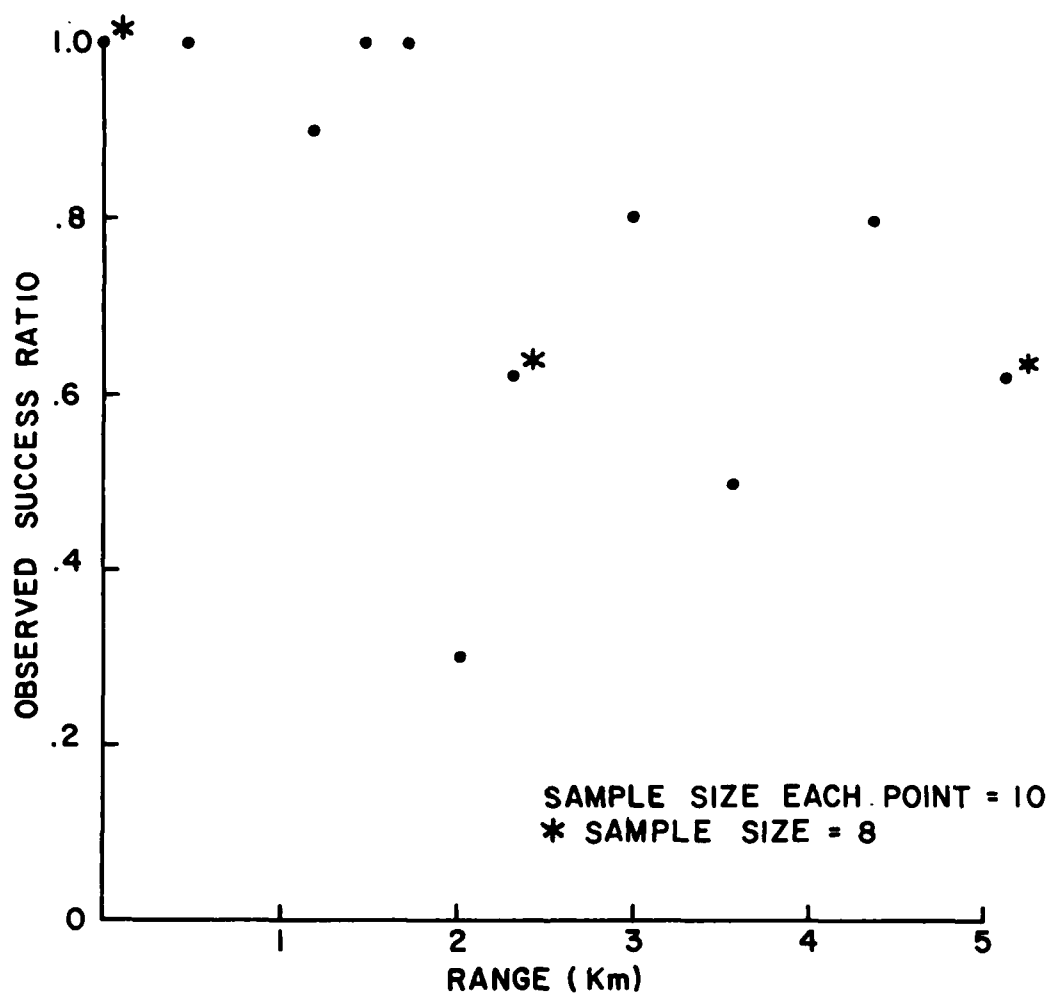
SUCCESS RATIO AS A FUNCTION OF RANGE

Figure 7. Example of the basic data from communications trials, PRC-77, 30 MHz, Case "B", street-to-street.

Figure 7 gives the results of 104 attempts to communicate between City Hall and the Broad Street operator at 30 MHz. The data represent a total of five different tests (two directions each trial) for the first and second Philadelphia test series taken at 11 different positions on Broad Street for each test.

In this particular example and in all the other data reported, a success is a quality "3" or higher as discussed above.

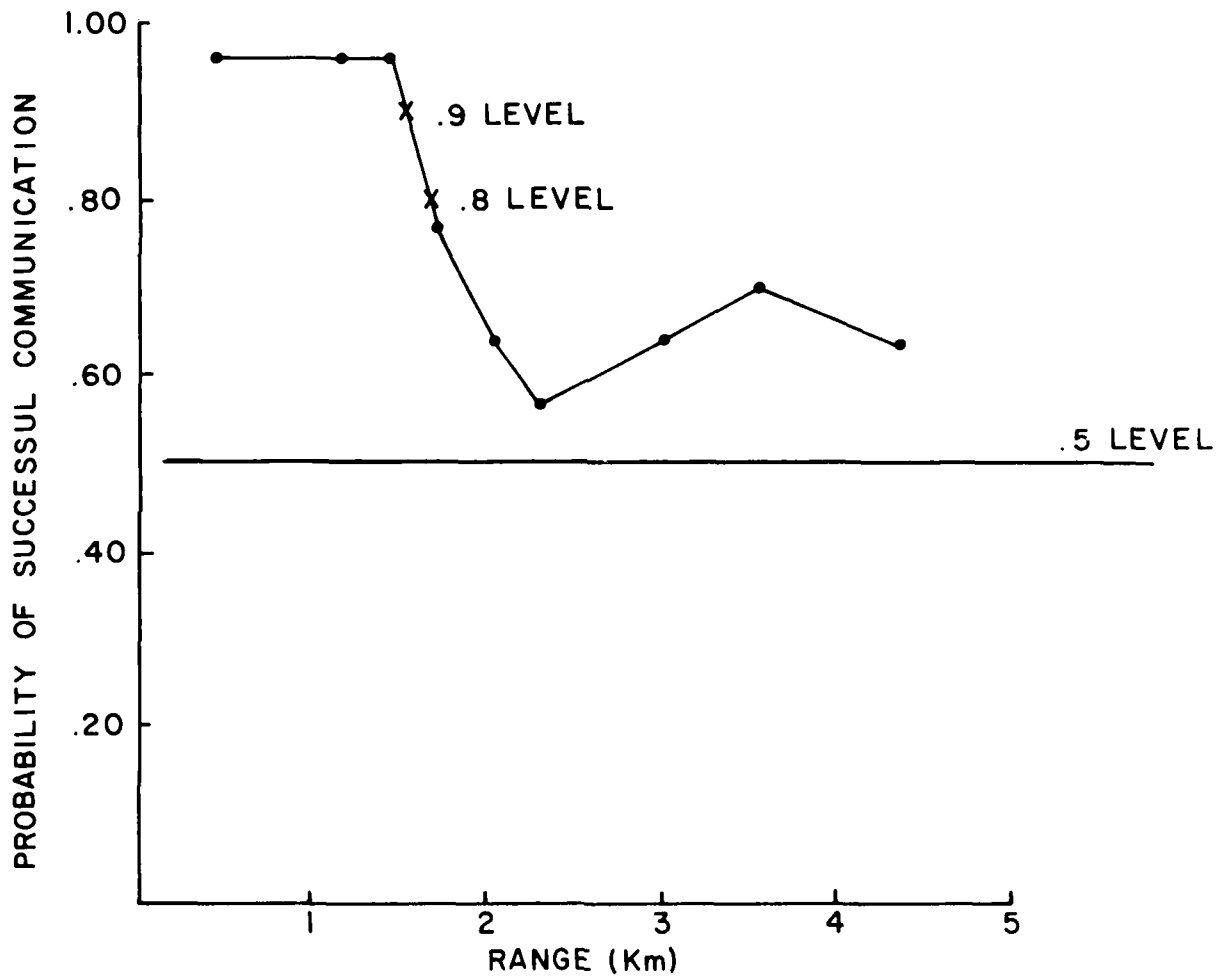
PREDICTED PERFORMANCE VS RANGE

Figure 8. Example of the smoothed data from communications trials, PRC-77, 30 MHz, Case "B", street-to-street.

Figure 8 displays the same data for 30 MHz although this time the curve is modified by three-point smoothing and the .9, .8 and .5 probability of success levels are indicated. These three levels of successful communication are used in the basic data comparison of Tables 2 and 3.

A peculiar problem of the data is evident in Figure 8 where probability of successful communication versus range is presented for the 30 MHz trials. The attempted communications were limited to 4.5 km range, and apparently this range was not sufficient to have the success ratio approach zero. Although the sampling rate was much lower (per kilometer) at the longer range, it does appear that there is some tendency for communications to improve at the longer ranges. Since the probability levels do not ever return to the .9 value, it was felt that the relatively high P values at long range should be discounted for the present until propagation phenomenon are better understood. Or an alternative way of stating the problem is; based on this data we do not want to give the impression that troops operating in a city can improve their communication performance by increasing the range between stations even though this may, on occasion, be true. It is doubtful that radio communications will ever be improved to a much higher level of reliability by having one operator increase his range from the station with which communications are being attempted.

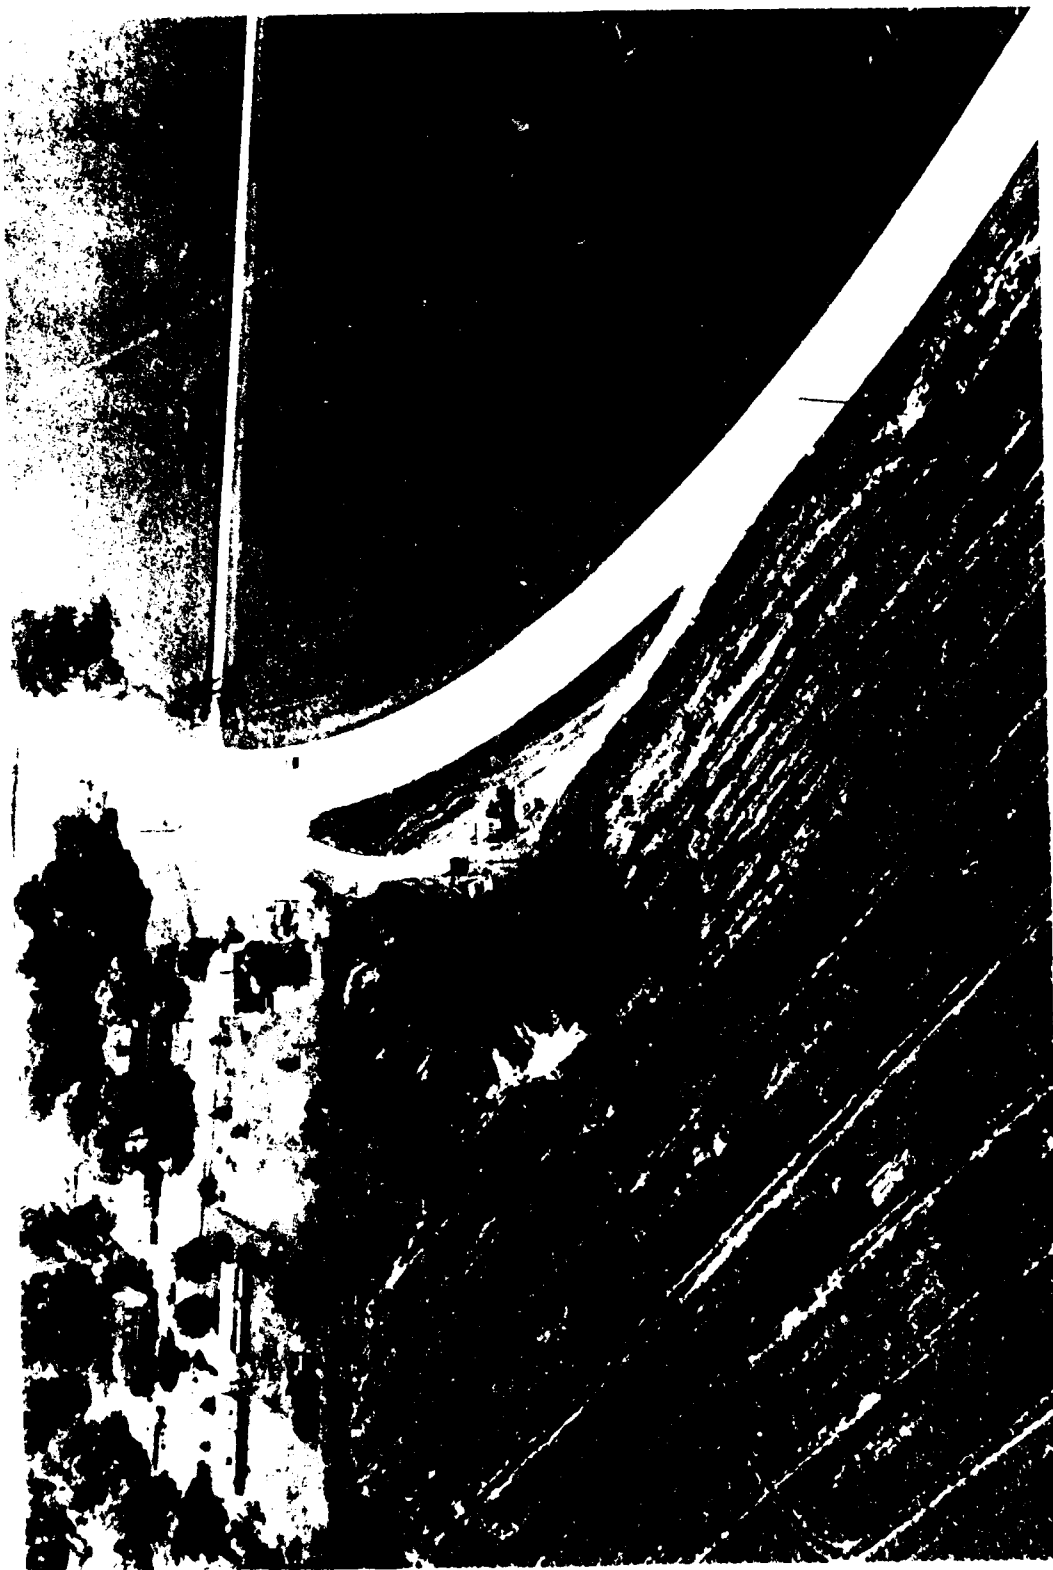
Figure 9. Aerial view of the control van located at Lynch, Maryland for the eastern shore trials.

Also included with this data for street-to-street performance (Tables 2 and 3) is a "Case A" which is the compilation of a series of tests in the open terrain of Maryland's flat Eastern Shore (Figures 9 and 10). The Eastern Shore tests were conducted at four different times with the same four PRC-77 sets as those used in the Philadelphia tests. The four Eastern Shore tests were conducted before, between, and after the two Philadelphia tests. The "open" tests were conducted in approximately the same manner as the Philadelphia tests with one stationary position (at Lynch in Kent County, Maryland) and one or more mobile stations attempting to communicate with each other and the stationary unit. Four different paths were traversed in the Eastern Shore trials; essentially north, south, east and west out of Lynch, Maryland.

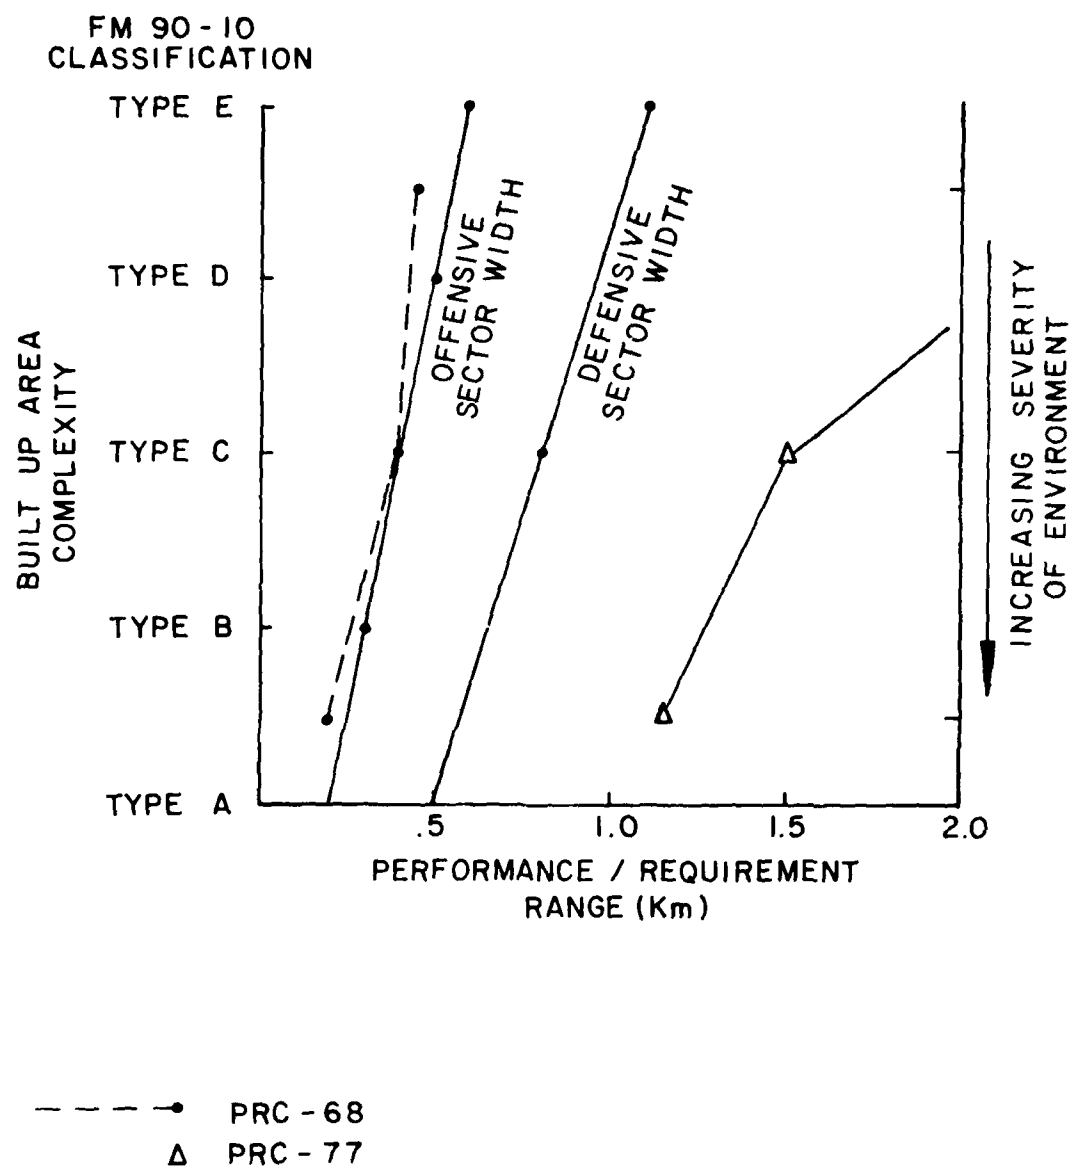
Figure 11. A comparison of company/team sector widths and radio performance range (P level, 50 MHz).

Figure 11 illustrates the change in maximum offensive and defensive sector widths as a function of complexity of built-up areas (Pages 2-15 and 3-17 of FM 90-10). Also included in the same figure is the performance of PRC-77 and PRC-68 radios as a function of the severity of the communications environment. Although the two classifications, i.e., complexity of built-up area and severity of communications environments do not precisely correspond, the two are closely related. Thus, the figure attempts to display both the performance requirements (sector width) and the measured performance (from the repeated tests) of the two communication systems for street-to-street operations.

We would conclude from this figure that the PRC-77 is adequate for netting Battalion units for defensive operations. (However, CP to CP communications in the defense present another problem discussed in the building-to-building tests below!) The PRC-68, however, would be limited to company/team level operations in the less demanding offensive role, but as a squad radio, the PRC-68 should be capable of operating with the required range for the platoon, even in the defense. The performance of the old squad radio, not included in Figure 9, would not be adequate for MOBA operations.
